SETUP MANUAL

***Midmark Products over Thin Client using
IQpath[®] or COM port mapping
Version 3.0***

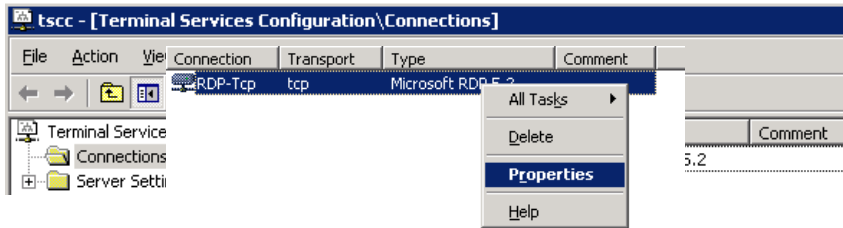
1. To open Microsoft Remote Connection, go to *Administrative Tools* and select *Terminal Services Configuration*, on the server.

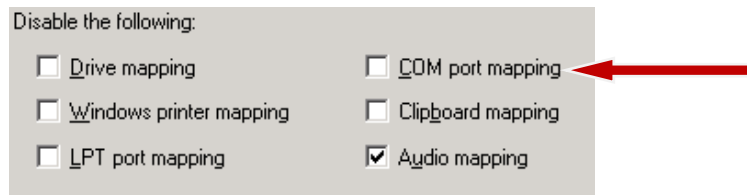
2. Right-click *RDP-tcp* and then select *Properties*.
3. You need to make sure that the *COM Port Mapping* box is **NOT** checked.

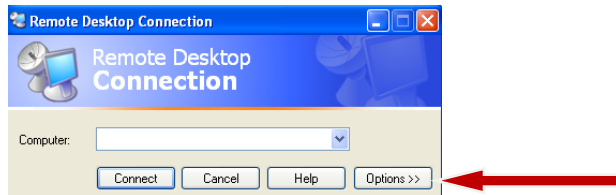
4. From the client computer, open the *RDP* connection and click **Options**.

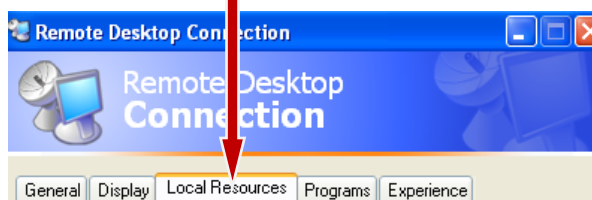
5. Click on the *Local Resources* tab.

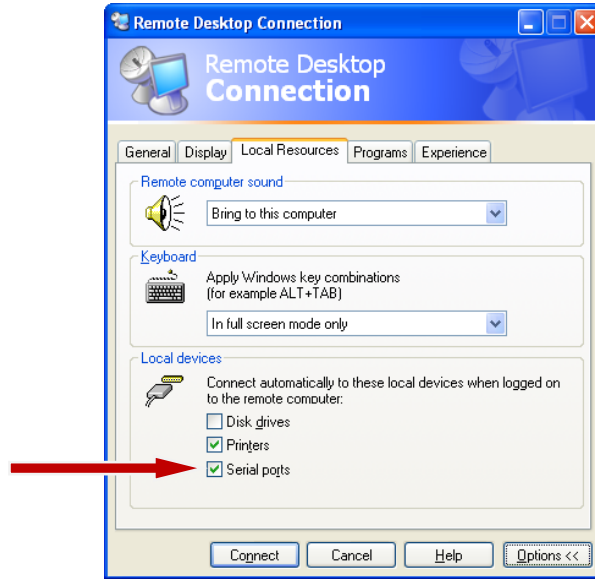
6. Ensure that the *Serial ports* box is checked.

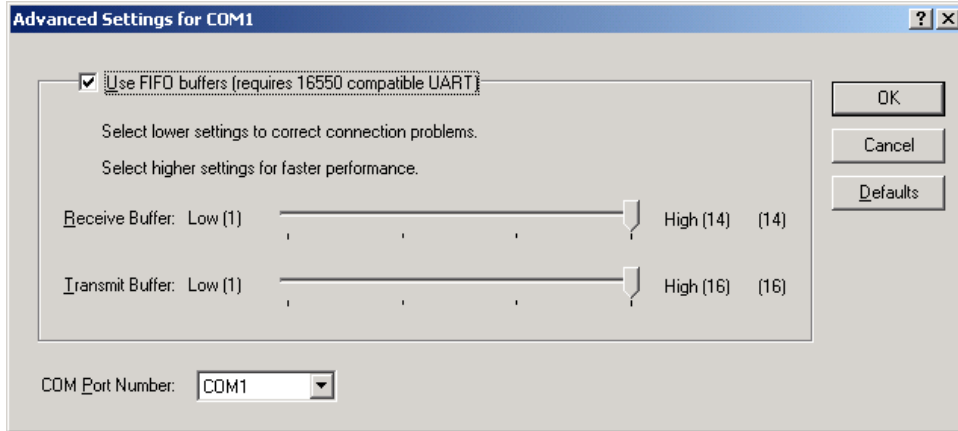
1. **Start** → **Settings** → **Control Panel** → **System** → *Hardware* tab → **Device Manager**
2. Expand *Ports (COM & LPT)* → choose the port that connects to the ECG module
3. Right-click → *Properties* → *Port Settings* tab → **Advanced**
4. The settings should be set as follows:

5. Click **OK**, even if no changes were made.
6. Click **OK** to close each open window. DO NOT use **X** or **Cancel**.
7. Reboot the client computer.

Midmark has observed a 30 - 40% reduction in bandwidth requirements by implementing the above configuration changes in a test environment.

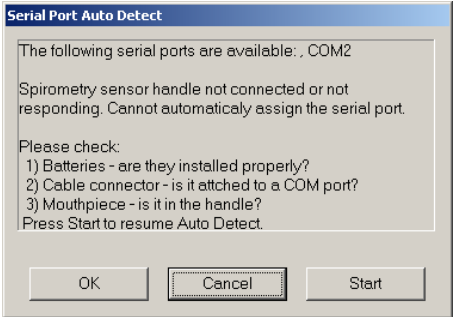
<p>A pop up dialog with the following message appears:</p> <p>Error: Unable to write to the Midmark VMware Spirometry virtual channel.</p>	<p>The Spirometry software running on the server computer was not able to write to the VMware IQpath® driver DLL on the client computer.</p> <p>One possible cause for this problem may be that the IQpath® driver DLLs have not been installed on the client computer. Install the Midmark IQpath® for VMware on the client computer and try again.</p> <p>Another possible cause is that registry keys for the current user have not been set. Terminate the thin client session and run the MidmarkVMwareVDI.reg file located in the C:\Midmark\ThinClient directory.</p>
<p>The following dialog box appears.</p>

<p>This is the auto-detection dialog box used for automatically detecting the Spirometry module when running as a fat-client or when using COM port mapping in a thin client environment.</p> <p>If this dialog box appears, then the Spirometry software did not detect it is being run in a thin client environment.</p> <p>To override the auto detection, choose Option 1 or 2 below:</p> <ol style="list-style-type: none"> 1. Add environment variable MIDMARK_THINCLIENT=<type> <p>OR</p> <ol style="list-style-type: none"> 2. Add registry Key HKEY_LOCAL_MACHINE/Software/Midmark/ThinClient/ThinClientType=<type> <p>Where <type> is of the following: "citrix", "rdp", or "vmware"</p> <p>Note: This is done on the server with the Midmark controls.</p>
